**Flood Control Project Maintenance
Levee Inspections**

Fall 2019 Levee Maintenance Deficiency Summary Report

Sacramento River Basin

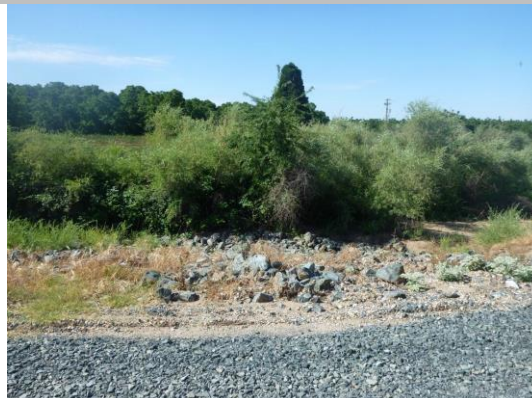
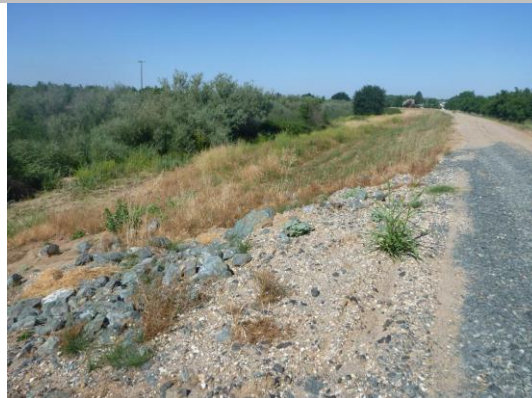
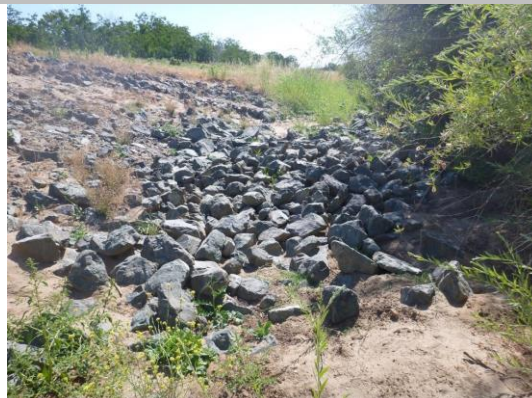
Photo 1 of 3 : LEVAL_FA_2019_135_296.jpg

LM Start	0.73	Rating **	A/W	Issue No.	9	
LM End	0.75	Issue Type +	Ma	Location *		
Category	Supplemental			GPS Latitude/Longitude		
				Start	End	
Item	2017 Storm Damage			38.975046°	38.975038°	
				-121.480938°	-121.481151°	
DWR ID	LMA-15					
Comment Code						
Inspector Comment						
Levee Evaluation Comments						
Description:						
Site ID No:135						
Site Designation:LMA-15						
Repair Type: Erosion						
Rating:Serious						
Field Date:6/6/2017						
Notes: Erosion of berm due to water flowing on berm toe road. Soil is silty sand and no veg or rock. X-section is from 1 of 2 emergency repairs that encroached into levee prism. Hole was backfilled with rock, about 7' deep.

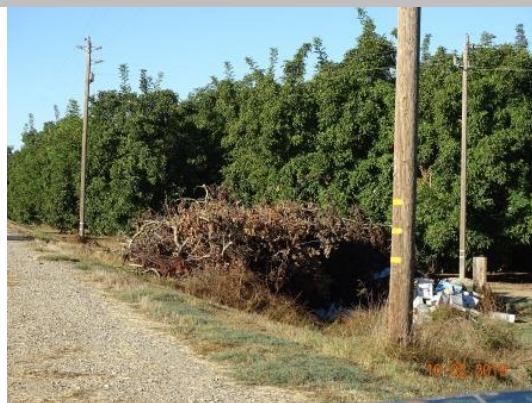
Photo 1 of 1 : FA_2019_RD1001_36_7_20191029_00022.jpg

LM Start	1.29	Rating **	U	Issue No.	7
LM End	1.29	Issue Type +	En	Location *	LS
Category	Earthen Levee			GPS Latitude/Longitude	
				Start	End
Item	Encroachments			38.972655 °	38.972655 °
				-121.490643 °	-121.490643 °
DWR ID	DWR_RD1001_01_f_2014_7				
Comment Code					
PR : Prunings					
Inspector Comment					
Prunings need to be removed off the levee toe, Fall 2019.

View of the landside looking downstream at prunings stacked up at the levee toe, Fall 2019.

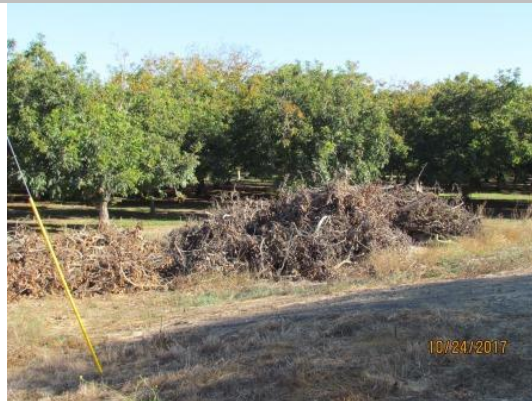
Photo 1 of 1 : FA_2019_RD1001_36_22_20190904_00014.jpg

LM Start	2.01	Rating **	U	Issue No.	22
LM End	2.01	Issue Type +	En	Location *	LS
Category	Earthen Levee			GPS Latitude/Longitude	
				Start	End
Item	Encroachments			38.971093 °	38.971093 °
				-121.502895 °	-121.502895 °
DWR ID	DWR_RD1001_01_f_2016_22				
Comment Code					
PR : Prunings					
Inspector Comment					
Prunings need to be removed, Fall 2019.

View of prunings on the landside toe looking upstream. Fall 2017.

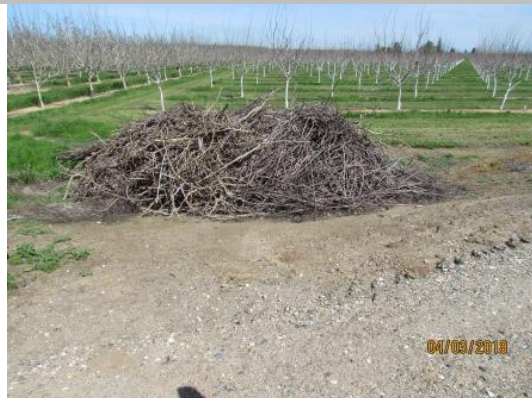
Photo 1 of 1 : FA_2019_RD1001_36_6_20190904_00004.jpg

LM Start	2.22	Rating **	M	Issue No.	6
LM End	2.22	Issue Type +	En	Location *	LS
Category	Earthen Levee			GPS Latitude/Longitude	
				Start	End
Item	Encroachments			38.969304 °	38.969304 °
				-121.506050 °	-121.506050 °
DWR ID	DWR_RD1001_01_f_2014_6				
Comment Code					
PR : Prunings					
Inspector Comment					
Prunings still at levee toe need to be removed, Fall 2019.

This photo was taken of the landside looking upstream at prunings stacked up at the levee toe.

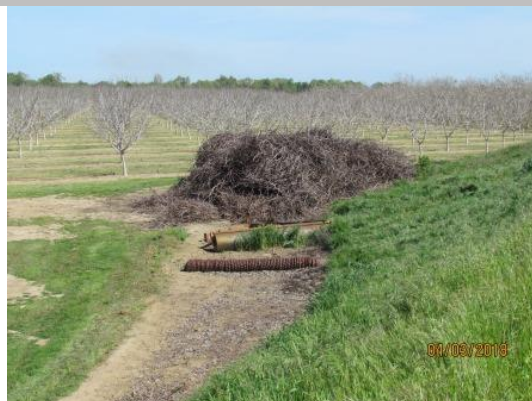
Photo 1 of 1 : FA_2019_RD1001_36_14_20190904_00010.jpg

LM Start	2.97	Rating **	M	Issue No.	14
LM End	2.97	Issue Type +	En	Location *	LS
Category	Earthen Levee			GPS Latitude/Longitude	
				Start	End
Item	Encroachments			38.966651 °	38.966651 °
				-121.518940 °	-121.518940 °
DWR ID	DWR_RD1001_01_s_2018_14				
Comment Code					
PR : Prunings					
Inspector Comment					
Remove prunings from levee toe, Fall 2019.

View looking upstream landside of prunings that have been placed at levee toe.

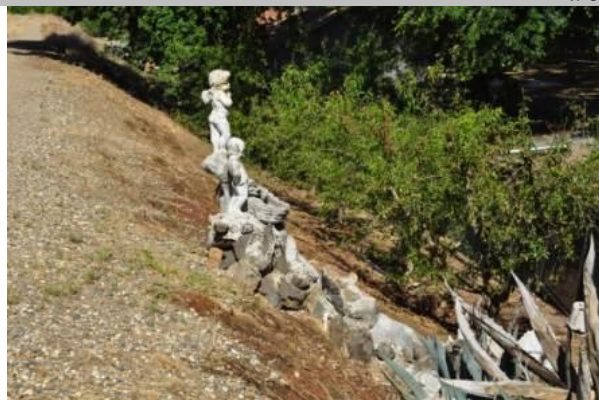
Photo 1 of 2 : FA_2019_RD1001_36_5_20190904_00002.jpg

LM Start	3.12	Rating **	M	Issue No.	5
LM End	3.17	Issue Type +	En	Location *	LS
Category	Earthen Levee			GPS Latitude/Longitude	
				Start	End
Item	Vegetation			38.965663 °	38.965705 °
				-121.521023 °	-121.522098 °
DWR ID	DWR_RD1001_01_s_2012_5				
Comment Code					
V6 : Landscaping					
Inspector Comment

Unit 1 Landscaping on landside levee slope.

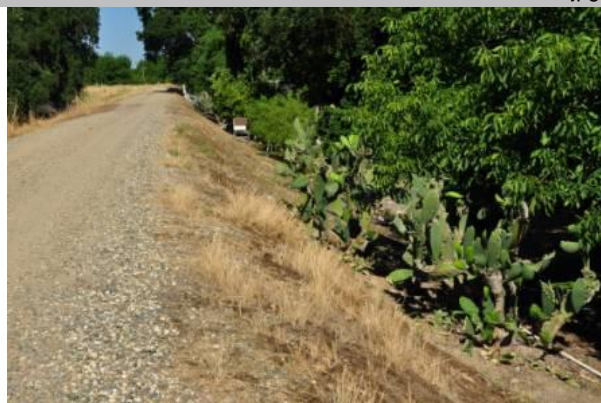
Photo 2 of 2 : FA_2019_RD1001_36_5_20190904_00003.jpg

LM Start	3.12	Rating **	M	Issue No.	5 (cont)	
LM End	3.17	Issue Type +	En	Location *	LS	
Category	Earthen Levee			GPS Latitude/Longitude		
				Start		End
Item	Vegetation			38.965663 °		38.965705 °
				-121.521023 °		-121.522098 °
DWR ID	DWR_RD1001_01_s_2012_5					
Comment Code						
V6 : Landscaping						
Inspector Comment

View of landscaping on landside slope.

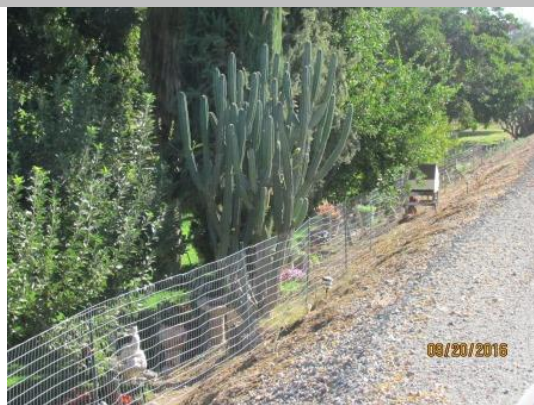
Photo 1 of 1 : FA_2019_RD1001_36_20_20190904_00013.jpg

LM Start	3.13	Rating **	M	Issue No.	20
LM End	3.17	Issue Type +	En	Location *	LS
Category	Earthen Levee			GPS Latitude/Longitude	
				Start	End
Item	Encroachments			38.965663 °	38.965672 °
				-121.521267 °	-121.521919 °
DWR ID	DWR_RD1001_01_f_2016_20				
Comment Code					
FE : Fence					
Inspector Comment					
Land owner has installed an unpermitted fence on the landside levee slope.

View of a fence on the landside levee slope looking upstream.

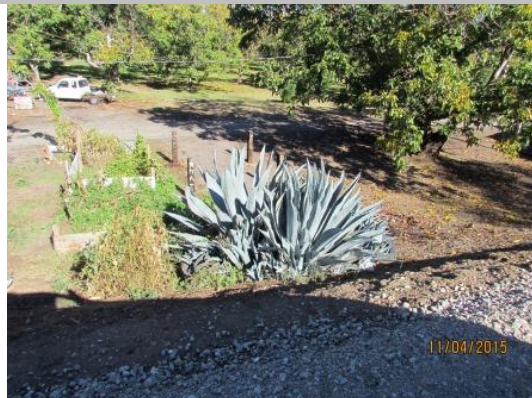
Photo 1 of 1 : FA_2019_RD1001_36_4_20190904_00001.jpg

LM Start	3.21	Rating **	U	Issue No.	4
LM End	3.21	Issue Type +	En	Location *	LS
Category	Earthen Levee			GPS Latitude/Longitude	
				Start	End
Item	Vegetation			38.965699 °	38.965699 °
				-121.522790 °	-121.522790 °
DWR ID	DWR_RD1001_01_f_2015_4				
Comment Code					
V6 : Landscaping					
Inspector Comment

View of the landscaping at the landside levee toe.

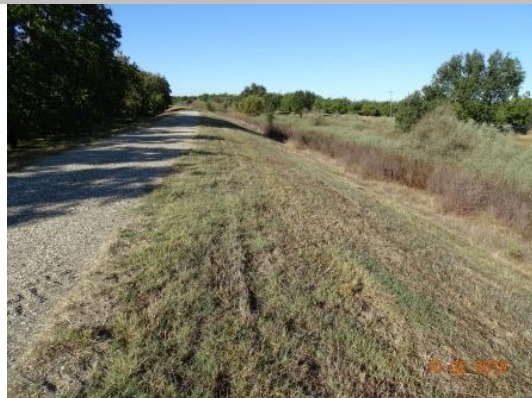
Photo 1 of 1 : FA_2019_RD1001_35_8_20191029_00027.jpg

LM Start	0.00	Rating **	A	Issue No.	8
LM End	3.61	Issue Type +	Ma	Location *	WS
Category	Earthen Levee			GPS Latitude/Longitude	
				Start	End
Item	Vegetation			38.971255 °	38.965598 °
				-121.474003 °	-121.533201 °
DWR ID	DWR_RD1001_02_f_2019_8				
Comment Code					
V1 : Control annual grass and weeds on the levee slopes and easements.					
Inspector Comment					
The annual vegetation is well maintained, Fall 2019.

View looking downstream waterside of the well maintained annual vegetation, Fall 2019.

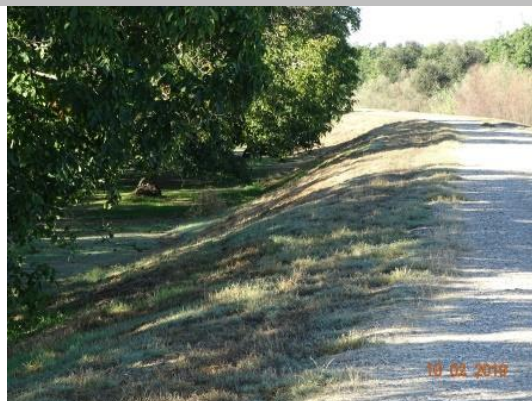
Photo 1 of 1 : FA_2019_RD1001_35_7_20191029_00026.jpg

LM Start	0.00	Rating **	A	Issue No.	7
LM End	3.61	Issue Type +	Ma	Location *	LS
Category	Earthen Levee			GPS Latitude/Longitude	
				Start	End
Item	Vegetation			38.971256 °	38.965598 °
				-121.474003 °	-121.533201 °
DWR ID	DWR_RD1001_02_f_2019_7				
Comment Code					
V1 : Control annual grass and weeds on the levee slopes and easements.					
Inspector Comment					
The annual vegetation is well maintained, Fall 2019.

View looking downstream landside of the well maintained annual vegetation, Fall 2019.

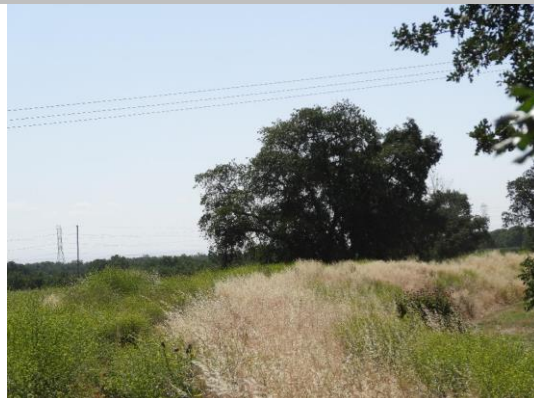
Photo 1 of 3 : UCIP_FA_2019_41673_22745.jpg

Comment Code						
Inspector Comment						
DS_ID:22536 FS_ID:41673 EP_NO: 5562 Repair Type: Non-Urgent Crossing Status: Found UCIP Comments: 05/23/2013 Pipe appears abandoned and if so should be done so properly. WS pipe plugged with stopper. Seems abandoned. Only abandoned pump base found. (P. Amatya - DWR UCIP) FIELD_STRUCT_DESC: 6-inch coated steel irrigation pipe through the levee, 3.5 feet below the crown. Metal cutoff collar placed on the pipe at the center of the levee crown. Pump was removed. Pump base on the waterside (WS) berm. Shutoff valve on the discharge side of the pump. Foot valve below water on the intake side of the pump. Siphon breaker on the landside (LS) shoulder. Pipe discharges into underground irrigation system on the LS. Power pole and meter box, 10 feet from the landward toe. 1.5-inch flexible conduit through levee, 3.5 feet below the crown. (Pump and 6-inch irrigation pipe authorized under Permit No. 5562, 1966 - Samuel B. Single). [Additional Reference(s): DWR Levee Log, 1993]. FS Date: 5/23/2013

Levee Crown: dense vegetation on levee crown and sides.

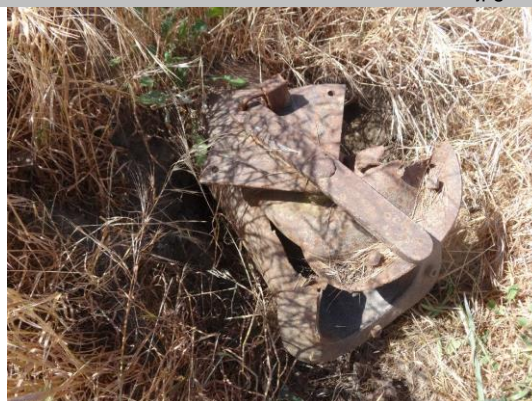
Photo 1 of 3 : UCIP_FA_2019_50740_22753.jpg

DS_ID:22529
FS_ID:50740
EP_NO: 2281
Repair Type: Non-Urgent
Crossing Status: Not Found
UCIP Comments: 01/17/2019 Records detailing the actions taken for the removal of the 7-inch pipe were recorded under file name LI10703_79259 document 20141008 CVFPB letter of acknowledgement available through permit records. (O. Magana - DWR UCIP)
07/13/2016 According to district president Joe Henderson, pipe was removed 2-3 years ago. No permit for removal found or evidence of pipe or its removal found. (K. Fazel - UCIP)
05/23/2013:- leaky pipe end and erosion on WS.- cracked dirt mound on LS - seems not been used for some time. (P. Amatya - DWR)
FIELD_STRUCT_DESC: *REMOVED* 7-inch steel irrigation pipe through the levee, 1.9 feet below the crown. Portable pump mounted on the bank during the summer months. Control valve on the waterside (WS). Steel plate bolted on the WS end during the winter months. Pipe discharges into a 30-inch concrete standpipe at the landside (LS) toe. (Pump and 7-inch irrigation pipe authorized under Permit No. 2281, 1956 - Willard R. Brown; 7-inch pipe through levee and concrete standpipe located on LS were removed as part of the 2013 USACE Periodic Inspection). [Additional Reference(s): DWR Levee Log, 1993].

WS- end of the pipe.

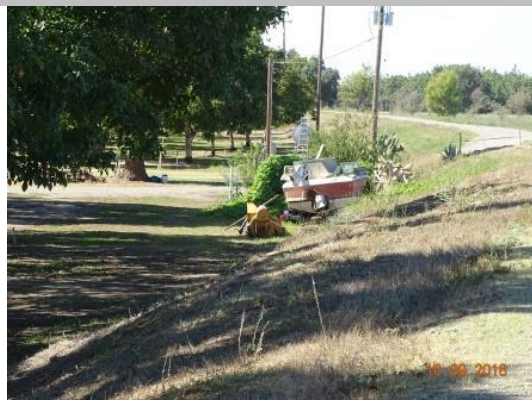
Photo 1 of 2 : FA_2019_RD1001_35_19_20190904_00008.jpg

LM Start	0.53	Rating **	M	Issue No.	19
LM End	0.53	Issue Type +	En	Location *	LS
Category	Earthen Levee			GPS Latitude/Longitude	
				Start	End
Item	Encroachments			38.974371 °	38.974371 °
				-121.481223 °	-121.481223 °
DWR ID	DWR_RD1001_02_f_2016_19				
Comment Code					
AV : Abandoned vehicles					
Inspector Comment					
Remove boat parked at the landside levee toe, Fall 2019.

View of a boat at the landside levee toe. Fall 2018.

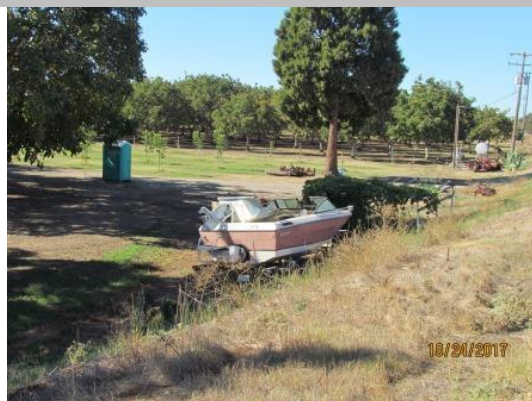
Photo 2 of 2 : FA_2019_RD1001_35_19_20190904_00009.jpg

LM Start	0.53	Rating **	M	Issue No.	19 (cont)	
LM End	0.53	Issue Type +	En	Location *	LS	
Category	Earthen Levee			GPS Latitude/Longitude		
				Start	End	
Item	Encroachments			38.974371 °	38.974371 °	
				-121.481223 °	-121.481223 °	
DWR ID	DWR_RD1001_02_f_2016_19					
Comment Code						
AV : Abandoned vehicles						
Inspector Comment						
Remove boat parked at the landside levee toe, Fall 2019.

View of a boat at the landside levee toe. Fall 2017.

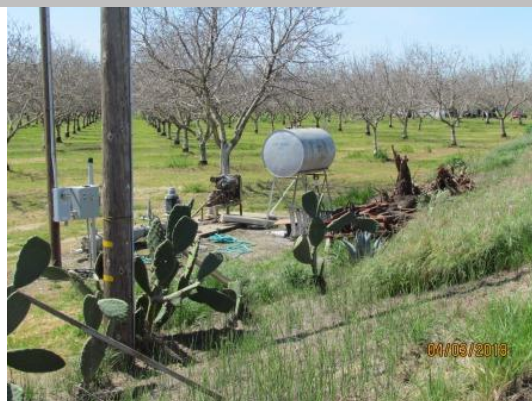
Photo 1 of 1 : FA_2019_RD1001_35_21_20190904_00010.jpg

LM Start	0.54	Rating **	M	Issue No.	21
LM End	0.54	Issue Type +	En	Location *	LS
Category	Earthen Levee			GPS Latitude/Longitude	
				Start	End
Item	Encroachments			38.974348 °	38.974348 °
				-121.481498 °	-121.481498 °
DWR ID	DWR_RD1001_02_f_2016_21				
Comment Code					
TA : Tank					
Inspector Comment					
Tank at landside levee toe needs to be removed from easement.

View looking downstream landside, equipment has been moved but fuel tank remains.

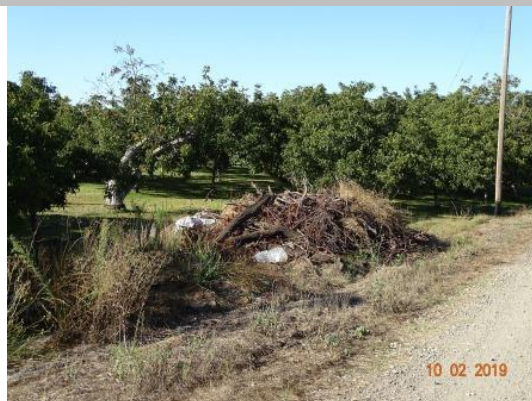
Photo 1 of 1 : FA_2019_RD1001_35_22_20191029_00029.jpg

LM Start	0.78	Rating **	M	Issue No.	22
LM End	0.78	Issue Type +	En	Location *	LS
Category	Earthen Levee			GPS Latitude/Longitude	
				Start	End
Item	Encroachments			38.973509 °	38.973509 °
				-121.485668 °	-121.485668 °
DWR ID	DWR_RD1001_02_f_2016_22				
Comment Code					
DE : Debris					
Inspector Comment					
Debris has been piled up again, Fall 2019.

View of debris pile on the landside levee slope looking downstream, Fall 2019.

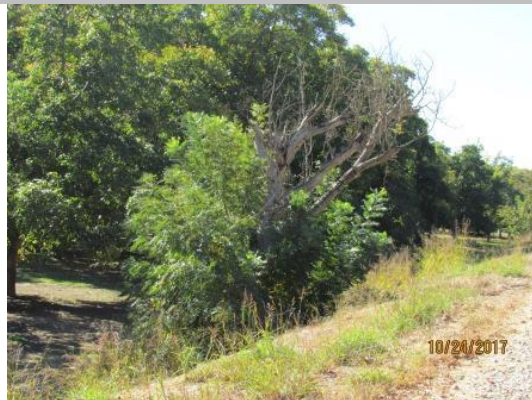
Photo 1 of 1 : FA_2019_RD1001_35_5_20190904_00001.jpg

LM Start	1.90	Rating **	M	Issue No.	5
LM End	1.90	Issue Type +	En	Location *	LS
Category	Earthen Levee			GPS Latitude/Longitude	
				Start	End
Item	Encroachments			38.969261°	38.969261°
				-121.504429°	-121.504429°
DWR ID	DWR_RD1001_02_f_2017_5				
Comment Code					
TR : Tree or limb					
Inspector Comment					
The farmer will not allow these stumps to be removed at this time, Fall 2019.

View looking downstream landside at a large stump that needs to be removed.

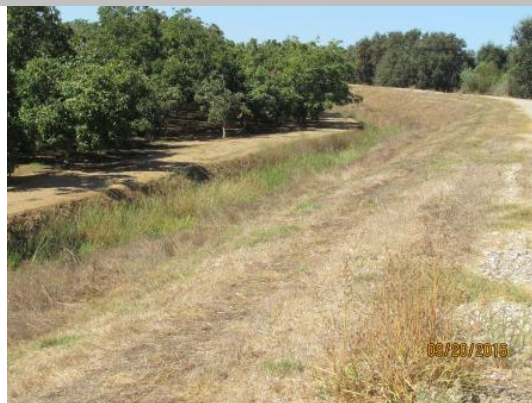
Photo 1 of 1 : FA_2019_RD1001_35_52_20190904_00016.jpg

LM Start	2.28	Rating **	M	Issue No.	52
LM End	2.52	Issue Type +	En	Location *	LS
Category	Earthen Levee			GPS Latitude/Longitude	
				Start	End
Item	Encroachments			38.967402°	38.967515°
				-121.510850°	-121.515270°
DWR ID	DWR_RD1001_02_s_2012_52				
Comment Code					
DT : Ditch					
Inspector Comment

View of landside irrigation ditch looking downstream.

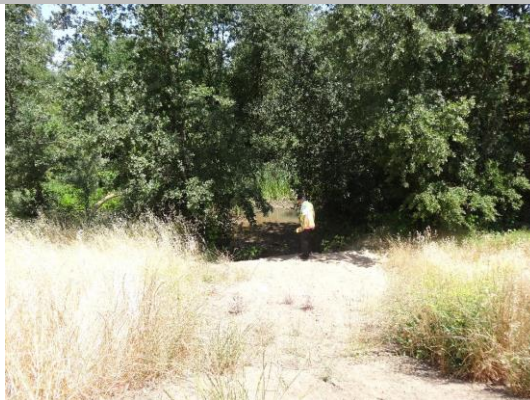
Photo 1 of 3 : UCIP_FA_2019_14008_23108.jpg

Comment Code					
Inspector Comment					
DS_ID:22543 FS_ID:14008 EP_NO: N/A Repair Type: Non-Urgent Crossing Status: Found UCIP Comments: 05/23/2013 - slide gate in inlet pipe on landside - pits on pipe due to corrosion (P. Amatya - DWR UCIP) FIELD_STRUCT_DESC: 36-inch corrugated metal gravity drainage pipe through the levee, 15 feet below the crown. Flap gate and concrete U-shaped headwall at outfall on the waterside (WS) end. Slide gate at inlet on the landside (LS) end. (Reclamation District No. 1001). [Additional Reference(s): DWR Levee Log, 1993. USACE Sacramento O&M Manual 141.1, August 1955, (Station 67+75)]. FS Date: 5/23/2013

WS- overview of waterside of the levee.

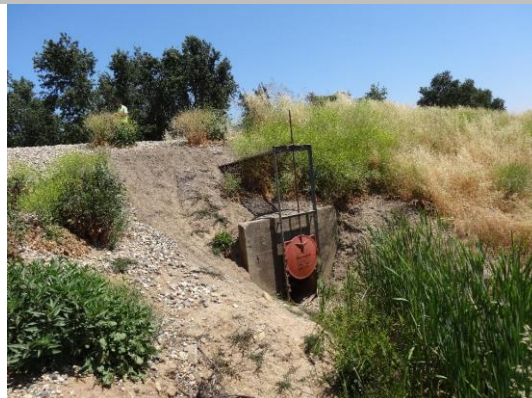
Photo 3 of 3 : UCIP_FA_2019_14008_23106.jpg

Comment Code						
Inspector Comment						
DS_ID:22543 FS_ID:14008 EP_NO: N/A Repair Type: Non-Urgent Crossing Status: Found UCIP Comments: 05/23/2013 - slide gate in inlet pipe on landside - pits on pipe due to corrosion (P. Amatya - DWR UCIP) FIELD_STRUCT_DESC: 36-inch corrugated metal gravity drainage pipe through the levee, 15 feet below the crown. Flap gate and concrete U-shaped headwall at outfall on the waterside (WS) end. Slide gate at inlet on the landside (LS) end. (Reclamation District No. 1001). [Additional Reference(s): DWR Levee Log, 1993. USACE Sacramento O&M Manual 141.1, August 1955, (Station 67+75)]. FS Date: 5/23/2013

LS- slide gate in inlet pipe structure

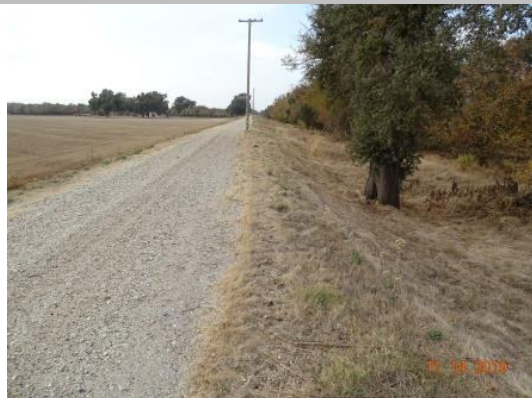
Photo 1 of 1 : FA_2019_RD1001_37_8_20191118_00036.jpg

LM Start	0.01	Rating **	A	Issue No.	8
LM End	12.56	Issue Type +	Ma	Location *	WS
Category	Earthen Levee			GPS Latitude/Longitude	
				Start	End
Item	Vegetation			39.006582°	38.941320°
				-121.375134°	-121.567486°
DWR ID	DWR_RD1001_03_f_2019_8				
Comment Code					
V1 : Control annual grass and weeds on the levee slopes and easements.					
Inspector Comment					
The annual vegetation is well maintained, Fall 2019.

View looking downstream waterside at the well maintained annual vegetation, Fall 2019.

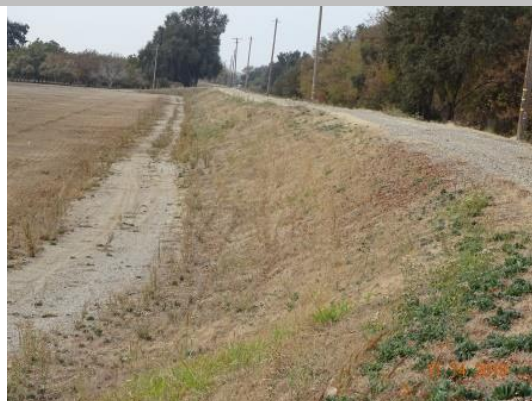
Photo 1 of 1 : FA_2019_RD1001_37_6_20191118_00037.jpg

LM Start	0.01	Rating **	A	Issue No.	6
LM End	12.56	Issue Type +	Ma	Location *	LS
Category	Earthen Levee			GPS Latitude/Longitude	
				Start	End
Item	Vegetation			39.006583 °	38.941320 °
				-121.375136 °	-121.567486 °
DWR ID	DWR_RD1001_03_f_2019_6				
Comment Code					
V1 : Control annual grass and weeds on the levee slopes and easements.					
Inspector Comment					
The annual vegetation is well maintained, Fall 2019.

View looking downstream landside at the well maintained annual vegetation, Fall 2019.

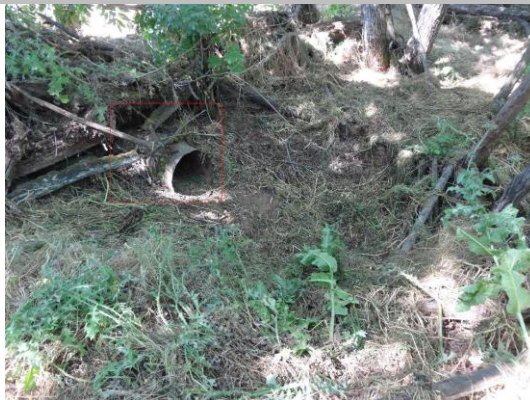
Photo 1 of 3 : UCIP_FA_2019_14128_23308.jpg

LM Start	0.88	Rating **	M	Issue No.	911	
LM End	0.88	Issue Type +	En	Location *		
Category	Supplemental			GPS Latitude/Longitude		
				Start	End	
Item	DRAFT DWR UCIP Field Study			39.006508 °	39.006508 °	
				-121.391086 °	-121.391086 °	
DWR ID	22549					
Comment Code						
Inspector Comment						
DS_ID:22549						
FS_ID:14128						
EP_NO: 958						
Repair Type: Non-Urgent						
Crossing Status: Found						
UCIP Comments: 05/21/2013 - slide gate on WS not found- needs abandoned properly. (P. Amatya - DWR UCIP)						
FIELD_STRUCT_DESC: *ABANDONED* 24-inch irrigation pipe of an unknown material through the levee, at an unknown depth. Slide gate on the waterside (WS) end. (24-inch irrigation pipe authorized under Permit No. 958, 1944 - Frank B. Lichty and Maggie Lichty).						
FS Date: 5/21/2013

WS- abandoned CMP on berm of the levee.

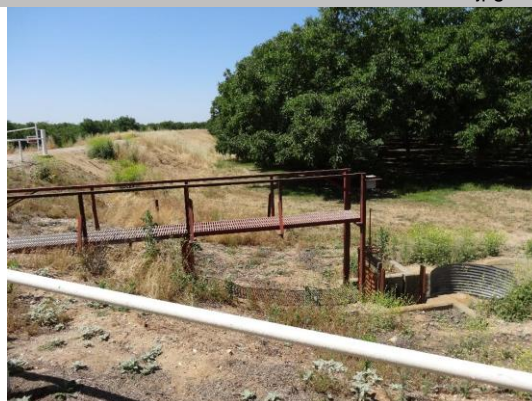
Photo 1 of 3 : UCIP_FA_2019_41727_23325.jpg

Comment Code						
Inspector Comment						
DS_ID:22561 FS_ID:41727 EP_NO: 4505 Repair Type: Non-Urgent Crossing Status: Found UCIP Comments: 05/21/2013 Two small steel pipes sleeved through 30-inch CMP may be a compliance issue as slide gate cannot close.- this may have been converted into drainage pipe (?) - big CMP standpipe on WS. (P. Amatya - DWR UCIP) FIELD_STRUCT_DESC: 30-inch concrete encased corrugated metal irrigation pipe through the levee, 11 feet below the crown. Concrete headwall and slide gate at the waterside (WS) toe, removed. Metal walkway on the WS to the slide gate. Pipe discharges into a 48-inch concrete standpipe at the landside (LS) toe. Two vertical pumps. (30-inch concrete encased corrugated metal irrigation pipe authorized under Permit No. 4505, 1964 - State of California, Department of Public Works, Division of Highways). [Additional Reference(s): DWR Levee Log, 1993. USACE Sacramento O&M Manual 141.1, August 1955, (Station 949+00), 30-inch steel pipe referenced]. FS Date: 5/21/2013

WS- steel walkway, CMP and concrete headwall

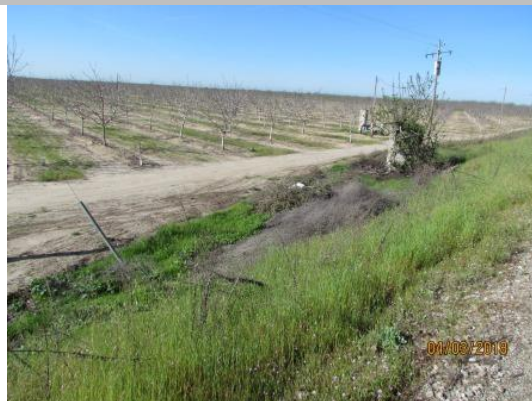
Photo 1 of 1 : FA_2019_RD1001_37_16_20190904_00011.jpg

LM Start	2.58	Rating **	M	Issue No.	16
LM End	2.58	Issue Type +	En	Location *	LS
Category	Earthen Levee			GPS Latitude/Longitude	
				Start	End
Item	Encroachments			38.995610 °	38.995610 °
				-121.417846 °	-121.417846 °
DWR ID	DWR_RD1001_03_s _ 2017_16				
Comment Code					
PR : Prunings					
Inspector Comment					
Prunings at levee toe need to be removed. Fall 2019.

View of prunings at levee toe landside that need to be removed.

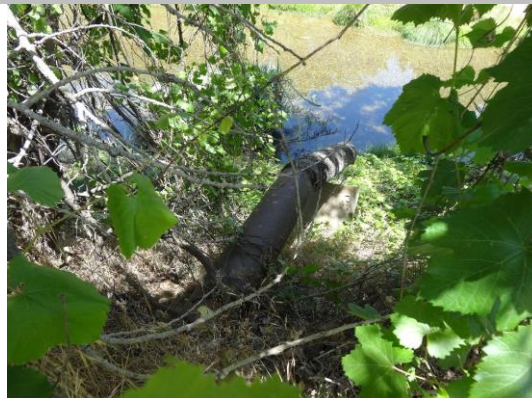
Photo 1 of 2 : UCIP_FA_2019_41722_23338.jpg

Comment Code					
Inspector Comment					
DS_ID:22562					
FS_ID:41722					
EP_NO: N/A					
Repair Type: Non-Urgent					
Crossing Status: Found					
UCIP Comments: 05/21/2013 Verify pipe has been abandoned properly.- pump mounted on the riverbank not found, - butterfly valve in a 30-inch concrete riser at the waterward toe not found,- concrete box on landside not found- a big tree inside concrete standpipe on landside found. (P. Amatya - DWR UCIP)					
FIELD_STRUCT_DESC: *ABANDONED* 22-inch steel pipe through the levee, 18.3 feet below the crown. Pump mounted on the riverbank. Butterfly valve in a 30-inch concrete riser at the waterside (WS) toe. Pipe discharges into a concrete box and concrete standpipe on the landside (LS). Steel plate bolted to the WS end of the pipe during the winter months. (California Packing Corporation). [Additional Reference(s): DWR Levee Log, 1993].					
FS Date: 5/21/2013

WS- only a steel pipe found on riverbank.

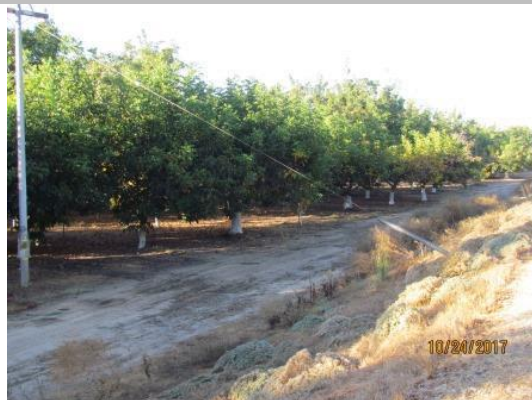
Photo 1 of 1 : FA_2019_RD1001_37_54_20190904_00027.jpg

LM Start	3.03	Rating **	M	Issue No.	54
LM End	3.03	Issue Type +	En	Location *	LS
Category	Earthen Levee			GPS Latitude/Longitude	
				Start	End
Item	Encroachments			38.993838 °	38.993838 °
				-121.425829 °	-121.425829 °
DWR ID	DWR_RD1001_03_f_2017_54				
Comment Code					
PO : Pole					
Inspector Comment					
There is a guy wire in the levee slope near the crown.

View looking downstream landside of a guy wire into the levee slope.

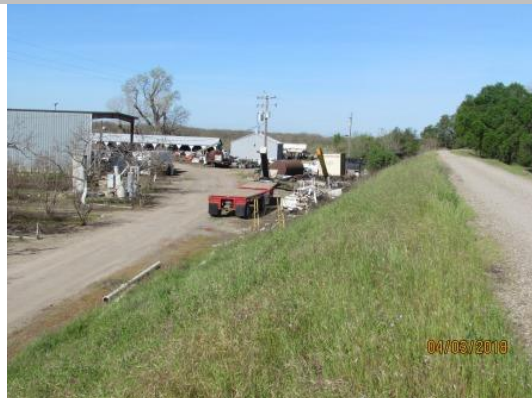
Photo 1 of 2 : FA_2019_RD1001_37_7_20190904_00003.jpg

LM Start	4.01	Rating **	M	Issue No.	7
LM End	4.25	Issue Type +	En	Location *	LS
Category	Earthen Levee			GPS Latitude/Longitude	
				Start	End
Item	Encroachments			38.991261 °	38.991927 °
				-121.443444 °	-121.447765 °
DWR ID	DWR_RD1001_03_s_2012_7				
Comment Code					
MA : Material					
Inspector Comment					
Land owner continues to leave debris and equipment next to levee toe, Fall 2019.

Irrigation pipe equipment and plastic cans within the easement of the levee.

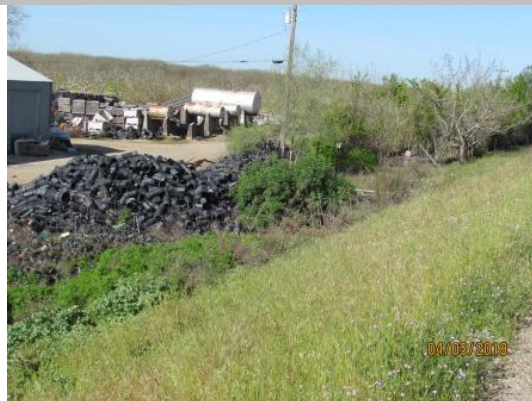
Photo 2 of 2 : FA_2019_RD1001_37_7_20190904_00004.jpg

Irrigation pipe equipment and plastic cans within the easement of the levee.

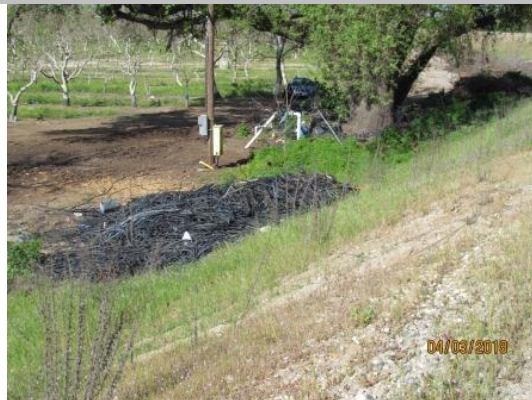
Photo 1 of 1 : FA_2019_RD1001_37_26_20190904_00016.jpg

LM Start	4.24	Rating **	M	Issue No.	26
LM End	4.24	Issue Type +	En	Location *	LS
Category	Earthen Levee			GPS Latitude/Longitude	
				Start	End
Item	Encroachments			38.991926 °	38.991926 °
				-121.447669 °	-121.447669 °
DWR ID	DWR_RD1001_03_s_2017_26				
Comment Code					
LI : Landscape Irrigation					
Inspector Comment					
Remove drip irrigation and trash from levee slope. Fall 2019.

View of the same drip irrigation and trash on levee slope.

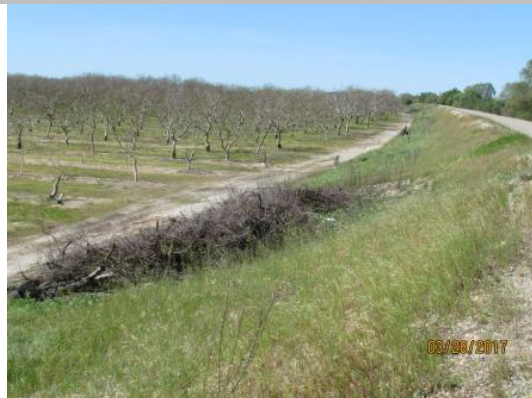
Photo 1 of 1 : FA_2019_RD1001_37_9_20190904_00005.jpg

LM Start	4.47	Rating **	M	Issue No.	9
LM End	4.69	Issue Type +	En	Location *	LS
Category	Earthen Levee			GPS Latitude/Longitude	
				Start	End
Item	Encroachments			38.991862°	38.991400°
				-121.451848°	-121.455901°
DWR ID	DWR_RD1001_03_s_2013_9				
Comment Code					
PR : Prunings					
Inspector Comment					
Remove prunings from levee toe, Fall 2019.

There is a still a pile of prunings at the toe.

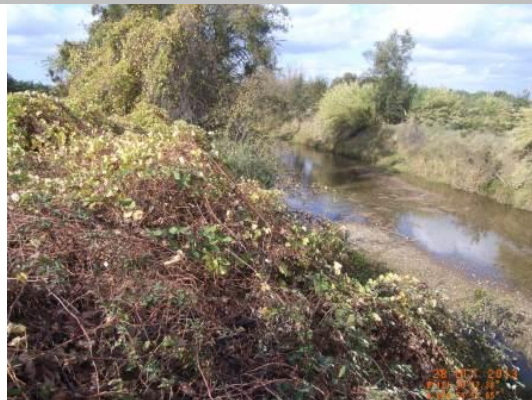
Photo 1 of 1 : FA_2019_RD1001_37_13_20190904_00009.jpg

LM Start	7.22	Rating **	A/W	Issue No.	13
LM End	7.31	Issue Type +	Ma	Location *	WS
Category	Supplemental			GPS Latitude/Longitude	
				Start	End
Item	2017 USACE Erosion Survey			38.982737 °	38.982572 °
				-121.501144 °	-121.502797 °
DWR ID	DWR_RD1001_03_f_2018_13				
Comment Code					
Inspector Comment					
2017 Site ID: BER 5.7 L					
Status: Eroding					
2017 Field Notes: Minor new erosion observed.					
Site History: 2008 - Sandy/silty banks with rotational slab failures					
creating near vertical bank with pop-outs due to tree failures. Narrow					
berm.

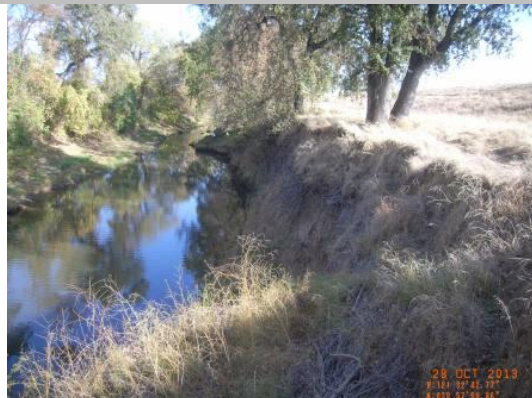
Photo 1 of 1 : FA_2019_RD1001_37_12_20190904_00008.jpg

LM Start	10.36	Rating **	A/W	Issue No.	12
LM End	10.40	Issue Type +	Ma	Location *	WS
Category	Supplemental			GPS Latitude/Longitude	
				Start	End
Item	2017 USACE Erosion Survey			38.964583 °	38.964010 °
				-121.544967 °	-121.545228 °
DWR ID	DWR_RD1001_03_f_2018_12				
Comment Code					
Inspector Comment					
2017 Site ID: BER 2.5 L					
Status: Eroding					
2017 Field Notes: Erosion pockets have expanded					
Site History: 2011 - Large section of bank has slumped off. RD has					
flagged and appears to be watching. 2012 - Slopes slightly steeper.					
2013 - Minor new erosion observed.

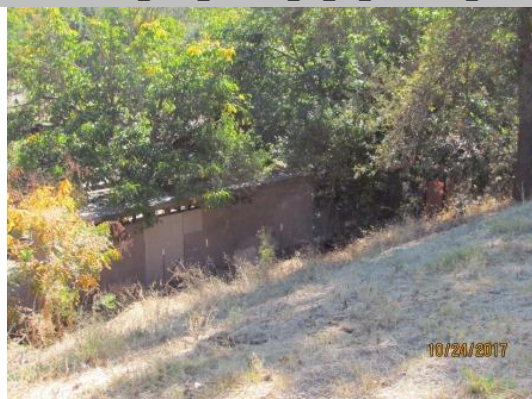
Photo 1 of 1 : FA_2019_RD1001_37_11_20190904_00007.jpg

LM Start	10.49	Rating **	U	Issue No.	11
LM End	10.49	Issue Type +	En	Location *	LS
Category	Earthen Levee			GPS Latitude/Longitude	
				Start	End
Item	Encroachments			38.962770 °	38.962770 °
				-121.545741 °	-121.545741 °
DWR ID	DWR_RD1001_03_f_2015_11				
Comment Code					
BU : Building					
Inspector Comment					
Small sheds are at levee toe.

View of building at the landside toe.

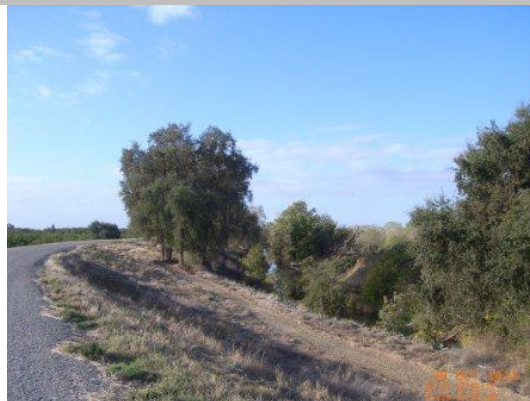
Photo 1 of 1 : FA_2019_RD1001_37_10_20190904_00006.jpg

LM Start	11.08	Rating **	A/W	Issue No.	10
LM End	11.16	Issue Type +	Ma	Location *	WS
Category	Supplemental			GPS Latitude/Longitude	
				Start	End
Item	2017 USACE Erosion Survey			38.955070 °	38.954227 °
				-121.549528 °	-121.550592 °
DWR ID	DWR_RD1001_03_f_2018_10				
Comment Code					
Inspector Comment					
2017 Site ID: BER 1.9 L					
Status: Eroding					
2017 Field Notes: Minor new erosion observed.					
Site History: 2011 - Large slumped sections of bank. 2012 - Slopes slightly steeper.

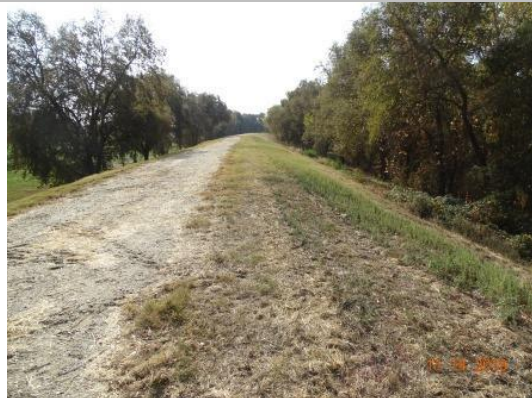
Photo 1 of 1 : FA_2019_RD1001_38_57_20191118_00074.jpg

LM Start	0.16	Rating **	A	Issue No.	57
LM End	13.26	Issue Type +	Ma	Location *	WS
Category	Earthen Levee			GPS Latitude/Longitude	
				Start	End
Item	Vegetation			38.938741 °	38.781222 °
				-121.567759 °	-121.605676 °
DWR ID	DWR_RD1001_04_f_2019_57				
Comment Code					
V1 : Control annual grass and weeds on the levee slopes and easements.					
Inspector Comment					
The annual vegetation is well maintained, Fall 2019.

View looking downstream waterside at the well maintained annual vegetation, Fall 2019.

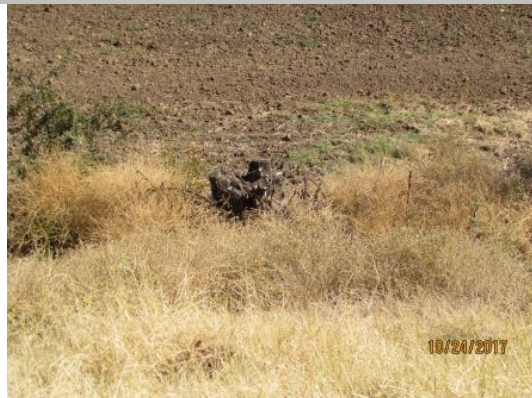
Photo 1 of 1 : FA_2019_RD1001_38_69_20190904_00035.jpg

LM Start	1.06	Rating **	N	Issue No.	69
LM End	1.06	Issue Type +	Ma	Location *	LS
Category	Earthen Levee			GPS Latitude/Longitude	
				Start	End
Item	Trim / Thin Trees			38.926128 °	38.926128 °
				-121.568241 °	-121.568241 °
DWR ID	DWR_RD1001_04_s_2016_69				
Comment Code					
T5 : Tree stumps.					
Inspector Comment					
Remove stump from levee toe, Fall 2019.

View of landside toe of a stump that needs to be removed.

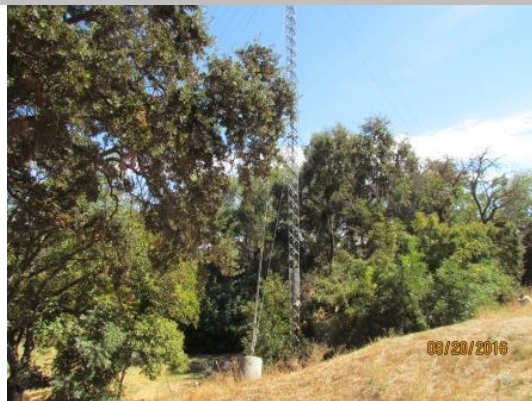
Photo 1 of 1 : FA_2019_RD1001_38_19_20190904_00008.jpg

LM Start	2.27	Rating **	M	Issue No.	19
LM End	2.27	Issue Type +	En	Location *	LS
Category	Earthen Levee			GPS Latitude/Longitude	
				Start	End
Item	Encroachments			38.909790 °	38.909790 °
				-121.574449 °	-121.574449 °
DWR ID	DWR_RD1001_04_s_2013_19				
Comment Code					
PO : Pole					
Inspector Comment

View of power pole and guy wire on the levee slope.

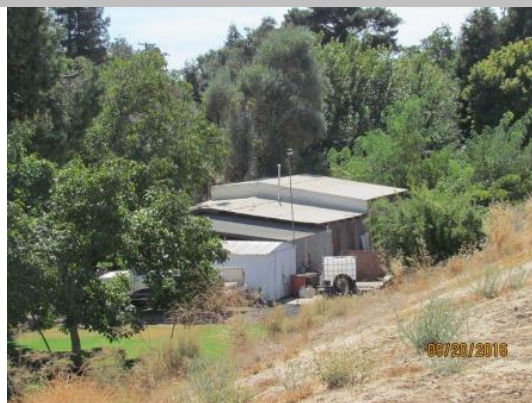
Photo 1 of 1 : FA_2019_RD1001_38_20_20190904_00009.jpg

View of buildings along the toe within the easement of the landside levee.

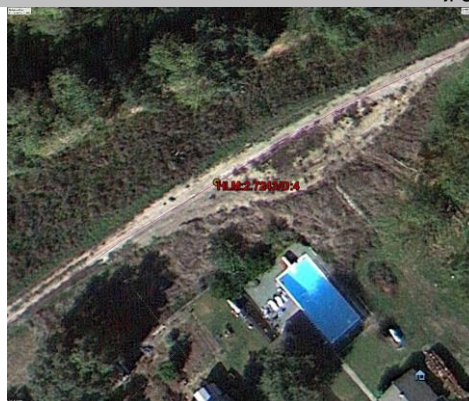
Photo 1 of 3 : UCIP_FA_2019_55162_24126.jpg

Comment Code					
Inspector Comment					
DS_ID:22568 FS_ID:55162 EP_NO: N/A Repair Type: Non-Urgent Crossing Status: Indicator Found UCIP Comments: 08/21/2019 Crossing remains Non-Urgent, unable to confirm if pipe found on the WS is the same pipe referenced in the DWR Levee Log. Need to contact property owner to determine if pipe still exists. (O. Magana - DWR UCIP)05/16/2013 Dense vegetation on slopes should be cleared. (P. Amatya - DWR UCIP) FIELD_STRUCT_DESC: 4-inch steel swimming pool drainage pipe through the levee, 3 feet below the crown. Open on the waterside (WS) end. Swimming pool on the landside (LS) toe. (Nate Wise). [Additional Reference(s): DWR Levee Log, 1993]. FS Date: 8/21/2019 12:59:00 PM

LS- only a private swimming pool found.

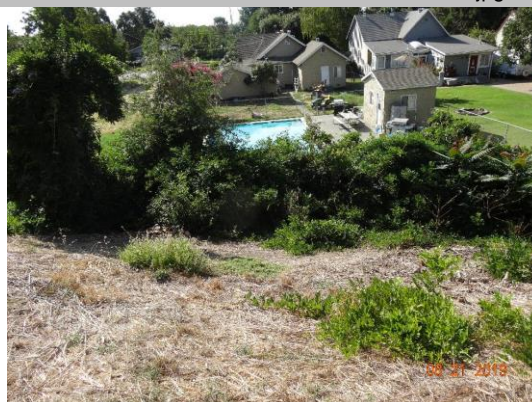
Photo 2 of 3 : UCIP_FA_2019_55162_81125.jpg

LS view: overview of LS.

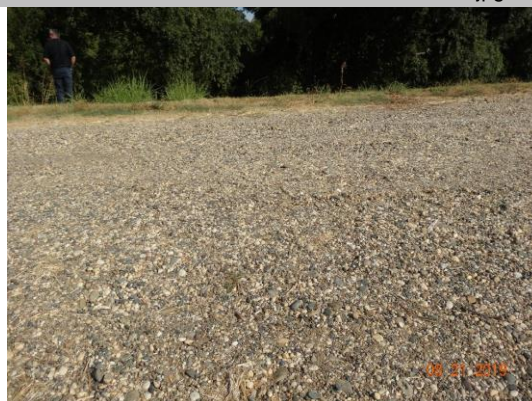
Photo 3 of 3 : UCIP_FA_2019_55162_81126.jpg

Comment Code						
Inspector Comment						
DS_ID:22568 FS_ID:55162 EP_NO: N/A Repair Type: Non-Urgent Crossing Status: Indicator Found UCIP Comments: 08/21/2019 Crossing remains Non-Urgent, unable to confirm if pipe found on the WS is the same pipe referenced in the DWR Levee Log. Need to contact property owner to determine if pipe still exists. (O. Magana - DWR UCIP)05/16/2013 Dense vegetation on slopes should be cleared. (P. Amatya - DWR UCIP) FIELD_STRUCT_DESC: 4-inch steel swimming pool drainage pipe through the levee, 3 feet below the crown. Open on the waterside (WS) end. Swimming pool on the landside (LS) toe. (Nate Wise). [Additional Reference(s): DWR Levee Log, 1993]. FS Date: 8/21/2019 12:59:00 PM

Overview of levee crown where pipe should cross the levee.

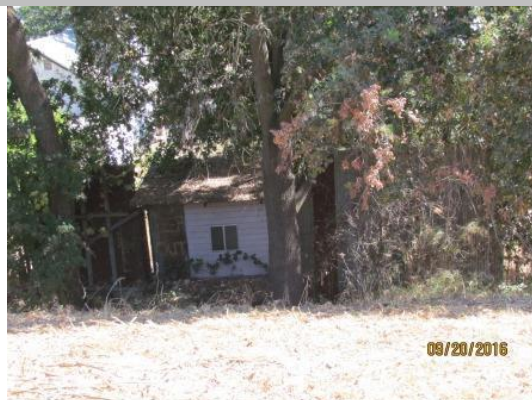
Photo 1 of 1 : FA_2019_RD1001_38_32_20190904_00015.jpg

LM Start	2.70	Rating **	M	Issue No.	32
LM End	2.70	Issue Type +	En	Location *	LS
Category	Earthen Levee			GPS Latitude/Longitude	
				Start	End
Item	Encroachments			38.904898 °	38.904898 °
				-121.578829 °	-121.578829 °
DWR ID	DWR_RD1001_04_f_2016_32				
Comment Code					
BU : Building					
Inspector Comment

View of shed at landside levee toe in the easement.

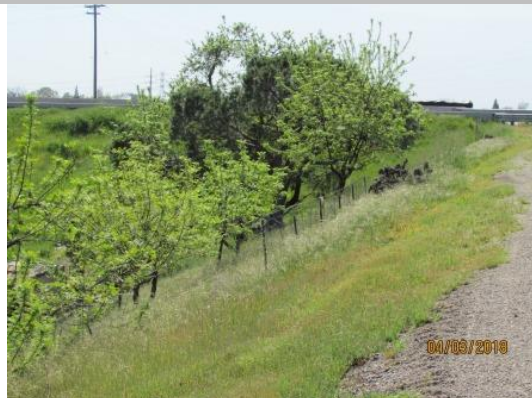
Photo 1 of 1 : FA_2019_RD1001_38_48_20190904_00023.jpg

LM Start	3.16	Rating **	M	Issue No.	48
LM End	3.19	Issue Type +	En	Location *	LS
Category	Earthen Levee			GPS Latitude/Longitude	
				Start	End
Item	Encroachments			38.899835 °	38.899499 °
				-121.583986 °	-121.584462 °
DWR ID	DWR_RD1001_04_s_2017_48				
Comment Code					
FE : Fence					
Inspector Comment					
Fence and landscaping have been placed by the land owner and still exist on levee slope and needs to be removed, Fall 2019.

View looking downstream landside of fence and landscaping that have been placed by the land owner on levee slope and needs to be removed, Spring 2018.

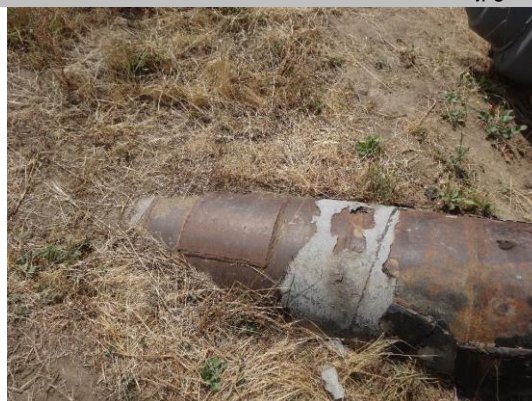
Photo 2 of 3 : UCIP_FA_2019_55167_24120.jpg

Comment Code						
Inspector Comment						
DS_ID:22571 FS_ID:55167 EP_NO: N/A Repair Type: Urgent Crossing Status: Found UCIP Comments: 08/21/2019 Crossing has been updated from No Action Needed to Urgent due to a scour section found at the WS toe. Pipe was running during inspection, no leaks were observed on the WS or LS. From the river survey, a scour section was visible at WS toe. Recommend monitoring site and coordinating with LMA to evaluate extent of damage. (O. Magana - DWR UCIP)05/16/2013 - working during field survey (P. Amatya - DWR UCIP) FIELD_STRUCT_DESC: 18-inch steel irrigation pipe through the levee, 3.5 feet below the crown. 40-horsepower slant pump mounted on the waterside (WS) slope. Siphon breaker on the landside (LS) slope. Pipe discharges into a 36-inch concrete standpipe on the LS. 1.25-inch electrical conduit through the levee, 3 feet below the crown. (no permit found authorizing 18-inch pipe; 40-horsepower slant pump and reinstallation of LS pipe authorized under Permit No. 5342, 1966 - Esther Scheiber). [Additional Reference(s): DWR Levee Log, 1993]. FS Date: 8/21/2019 1:01:00 PM

WS- steel pipe daylights at levee slope.

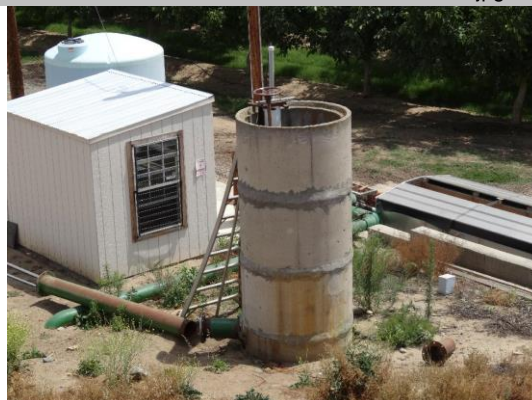
Photo 3 of 3 : UCIP_FA_2019_55167_24122.jpg

LS- concrete stand pipe at levee toe.

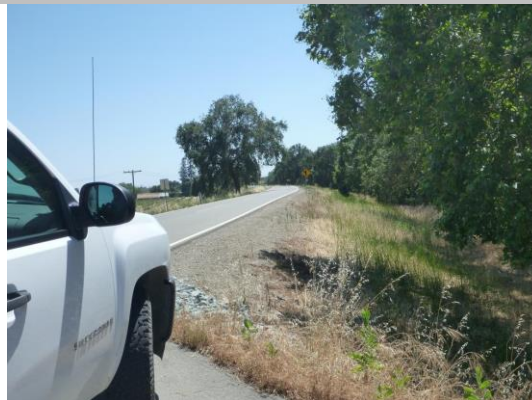
Photo 1 of 3 : LEVAL_FA_2019_139_1148.jpg

LM Start	5.61	Rating **	A/W	Issue No.	35
LM End		Issue Type +	Ma	Location *	WS
Category	Supplemental			GPS Latitude/Longitude	
				Start	End
Item	2017 Storm Damage			38.876374 °	°
				-121.613425 °	°
DWR ID	LMA-19				
Comment Code					
Inspector Comment					
Levee Evaluation Comments					
Description:					
Site ID No:139					
Site Designation:LMA-19					
Repair Type: Erosion					
Rating:Area of Concern					
Field Date:6/6/2017					
Notes: Several small erosion sites along 2 miles.

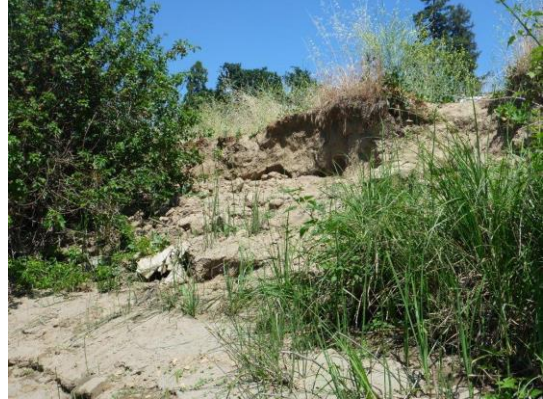
Photo 3 of 3 : LEVAL_FA_2019_139_1155.jpg

LM Start	5.61	Rating **	A/W	Issue No.	35 (cont)	
LM End		Issue Type +	Ma	Location *	WS	
Category	Supplemental			GPS Latitude/Longitude		
				Start	End	
Item	2017 Storm Damage			38.876374 °		°
				-121.613425 °		°
DWR ID	LMA-19					
Comment Code						
Inspector Comment						
Levee Evaluation Comments						
Description:						
Site ID No:139						
Site Designation:LMA-19						
Repair Type: Erosion						
Rating:Area of Concern						
Field Date:6/6/2017						
Notes: Several small erosion sites along 2 miles.

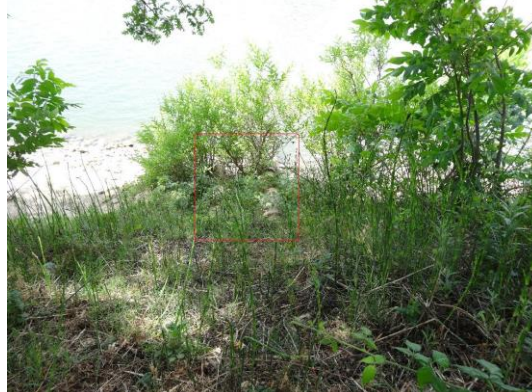
Photo 2 of 3 : UCIP_FA_2019_55170_24106.jpg

Comment Code						
Inspector Comment						
DS_ID:22573 FS_ID:55170 EP_NO: 10389-A Repair Type: Non-Urgent Crossing Status: Found UCIP Comments: 08/21/2019 Crossing remains Non-Urgent; Work still pending (logged under maintenance compliance issue), project is waiting on Status of Cultural report for Encroachment Permit Application No. 10389-A-1. Work involves modifying existing pumping plant removing and replacing existing 12-inch dia pressurized water pipe and electrical conduit, installing a 5-foot x 5-foot vault housing, new siphon breaker and butterfly valve, and name change. (O. Magana - DWR UCIP)01/24/2019 Project modification logged under Permit 10389-A-1 proposes removing and replacing existing 12-inch pressurized water pipe and conduit. Need to determine construction start date and obtain as-built drawing for new pipe. Pending actions: need to issue new UCIP dsid for new pipe and retire current dsid 22573. (O. Magana - DWR UCIP) 05/16/2013 - water leakage causes erosion on LS slope.- may be pressure breaker valve not closed properly on LS.- a 36-inch concrete standpipe at the landward toe not found. (P. Amatya - DWR UCIP) FIELD_STRUCT_DESC: 12-inch irrigation discharge pipe of an unknown material through the levee, 10 feet below the crown. 30-horsepower slant pump on the riverbank. Siphon breaker in a 24-inch corrugated metal pipe (CMP) riser on the landside (LS) slope. Pipe discharges into a 36-inch concrete standpipe at the LS toe. Pipe installed by USACE in 1963. Switch panel and service pole at the LS toe. (12-inch pipe and a 30-horsepower slant pump authorized under Permit No. 10389-A, 1974 - Pluma Orchards, also includes removal of existing pipe). [Additional Reference(s): DWR Levee Log, 1993]. FS Date: 8/21/2019 1:06:00 PM

WS- inlet pipe on the river bank.

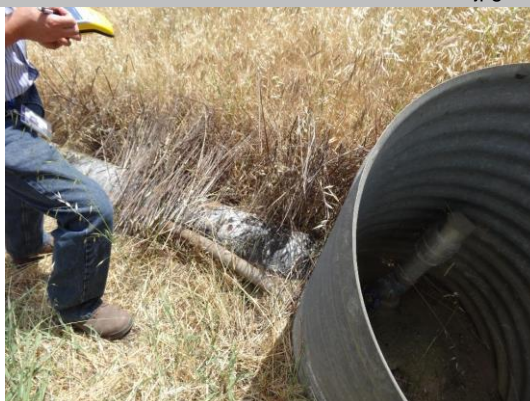
Photo 3 of 3 : UCIP_FA_2019_55170_24105.jpg

Comment Code						
Inspector Comment						
DS_ID:22573 FS_ID:55170 EP_NO: 10389-A Repair Type: Non-Urgent Crossing Status: Found UCIP Comments: 08/21/2019 Crossing remains Non-Urgent; Work still pending (logged under maintenance compliance issue), project is waiting on Status of Cultural report for Encroachment Permit Application No. 10389-A-1. Work involves modifying existing pumping plant removing and replacing existing 12-inch dia pressurized water pipe and electrical conduit, installing a 5-foot x 5-foot vault housing, new siphon breaker and butterfly valve, and name change. (O. Magana - DWR UCIP)01/24/2019 Project modification logged under Permit 10389-A-1 proposes removing and replacing existing 12-inch pressurized water pipe and conduit. Need to determine construction start date and obtain as-built drawing for new pipe. Pending actions: need to issue new UCIP dsid for new pipe and retire current dsid 22573. (O. Magana - DWR UCIP) 05/16/2013 - water leakage causes erosion on LS slope.- may be pressure breaker valve not closed properly on LS.- a 36-inch concrete standpipe at the landward toe not found. (P. Amatya - DWR UCIP) FIELD_STRUCT_DESC: 12-inch irrigation discharge pipe of an unknown material through the levee, 10 feet below the crown. 30-horsepower slant pump on the riverbank. Siphon breaker in a 24-inch corrugated metal pipe (CMP) riser on the landside (LS) slope. Pipe discharges into a 36-inch concrete standpipe at the LS toe. Pipe installed by USACE in 1963. Switch panel and service pole at the LS toe. (12-inch pipe and a 30-horsepower slant pump authorized under Permit No. 10389-A, 1974 - Pluma Orchards, also includes removal of existing pipe). [Additional Reference(s): DWR Levee Log, 1993]. FS Date: 8/21/2019 1:06:00 PM

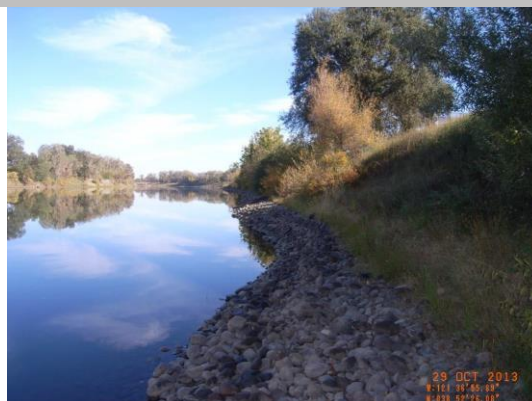
Photo 1 of 1 : FA_2019_RD1001_38_28_20190904_00012.jpg

LM Start	5.80	Rating **	A/W	Issue No.	28
LM End	5.93	Issue Type +	Ma	Location *	WS
Category	Supplemental			GPS Latitude/Longitude	
				Start	End
Item	2017 USACE Erosion Survey			38.874113 °	38.872373 °
				-121.615380 °	-121.616504 °
DWR ID	DWR_RD1001_04_f_2018_28				
Comment Code					
Inspector Comment					
2017 Site ID: FHR 6.6 L					
Status: Eroding					
2017 Field Notes: Sandy bank slope is unraveling.					
Site History: 2011 - Erosion pockets from tree popouts. Sections of the lower bank have slumped off. 2013 - Scallops from tree popouts no longer visible on site. Minor new erosion at the middle of the bank.					
2015 - Fres erosion from human usage.

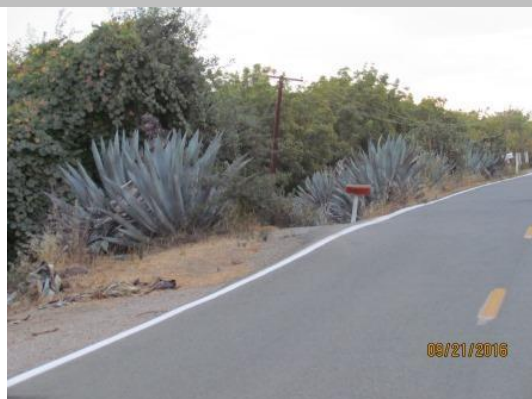
Photo 1 of 1 : FA_2019_RD1001_38_17_20190904_00006.jpg

LM Start	6.39	Rating **	U	Issue No.	17
LM End	6.46	Issue Type +	En	Location *	LS
Category	Earthen Levee			GPS Latitude/Longitude	
				Start	End
Item	Vegetation			38.866032 °	38.865195 °
				-121.619489 °	-121.620017 °
DWR ID	DWR_RD1001_04_s_2012_17				
Comment Code					
V6 : Landscaping					
Inspector Comment					
Home owners landscaping should be removed, Fall 2019.

View of landscaping on the landside shoulder and slope looking downstream.

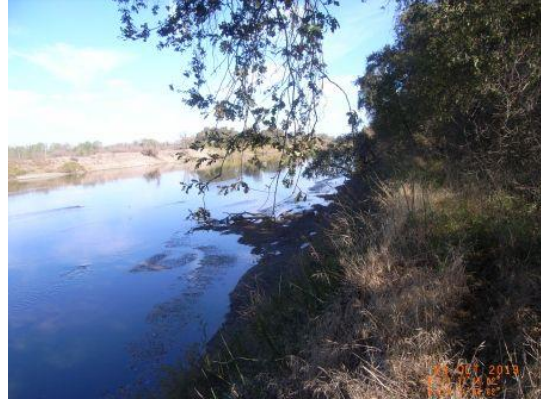
Photo 1 of 1 : FA_2019_RD1001_38_18_20190904_00007.jpg

LM Start	6.42	Rating **	A/W	Issue No.	18
LM End	6.51	Issue Type +	Ma	Location *	WS
Category	Supplemental			GPS Latitude/Longitude	
				Start	End
Item	2017 USACE Erosion Survey			38.865875 °	38.864706 °
				-121.619983 °	-121.620813 °
DWR ID	DWR_RD1001_04_f_2018_18				
Comment Code					
Inspector Comment					
2017 Site ID: FHR 6.0 L					
Status: Critical					
2017 Field Notes: Upgraded to critical, entire bank slope is slumping, with near vertical face					
Site History: 2011 - Tall slumping sections. Scour around trees has exposed most of the roots. 2016 - Recent large slope failure observed.

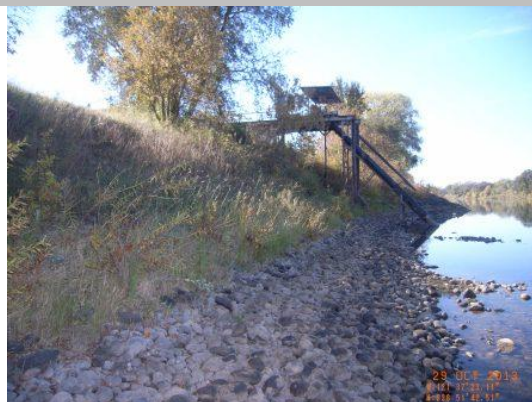
Photo 1 of 1 : FA_2019_RD1001_38_15_20190904_00005.jpg

LM Start	6.57	Rating **	A/W	Issue No.	15
LM End	6.77	Issue Type +	Ma	Location *	WS
Category	Supplemental			GPS Latitude/Longitude	
				Start	End
Item	2017 USACE Erosion Survey			38.863946 °	38.861558 °
				-121.621388 °	-121.623316 °
DWR ID	DWR_RD1001_04_f_2018_15				
Comment Code					
Inspector Comment					
2017 Site ID: FHR 5.8 L					
Status: Eroding					
2017 Field Notes: slope is not stable enough to maintain vegetation growth, new erosion					
Site History: 2011 - Large slumped sections on the lower bank. 2012 - New cracks observed.
